Validated Condition Assessment of Metallic Water Mains in the City of Gresham

Innovating Water Main Assessment with Confidence and Clarity

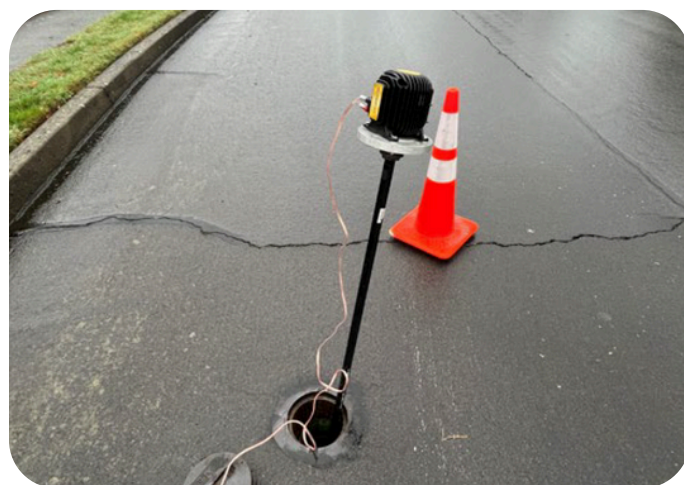
KenWave's DRI system in action: a wave generator introduces vibroacoustic signals into the pipeline to assess structural integrity—all without excavation. Photo taken during the Gresham, OR pilot project.

DRI works by generating and analyzing acoustic waves within the pipeline, identifying variations in material properties and detecting flaws or degradations. The technology's capability to provide a structural thickness profile with high resolution (6 feet) enabled efficient detection of degradation zones and structural inconsistencies. Even in areas with sparse access points, KenWave's DRI technology effectively extended its inspection capability up to 887 feet, demonstrating potential for reaching lengths up to 1,500 feet.

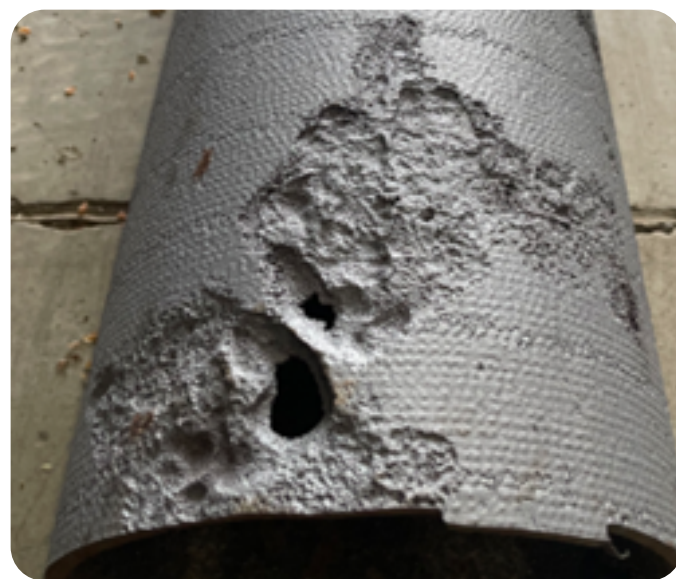
Validation of KenWave DRI technology showing at location 1 distress on a section of ductile iron pipe.

KenWave's application of DRI technology successfully achieved a structural thickness profile with a high resolution of 6 feet, pinpointing significant degradation across inspected lengths. To verify the DRI results, the City of Gresham conducted a validation project using ultrasonic testing (UT) on pipe coupons from seven specific locations. The UT testing corroborated the DRI findings with an impressive 95% to 99% accuracy rate, confirming the reliability of KenWave's technology in assessing both CI and DI pipes.

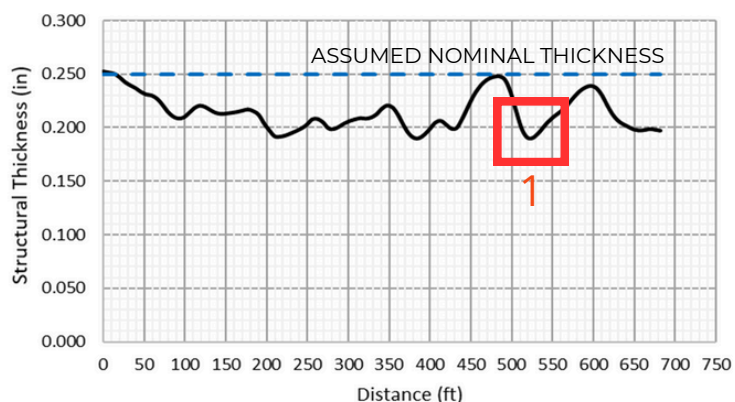
Graph showing structural thickness measurements along the length of metallic pipe.
