Validated Condition Assessment of Metallic Water Mains in the City of Gresham

Innovating Water Main Assessment with Confidence and Clarity

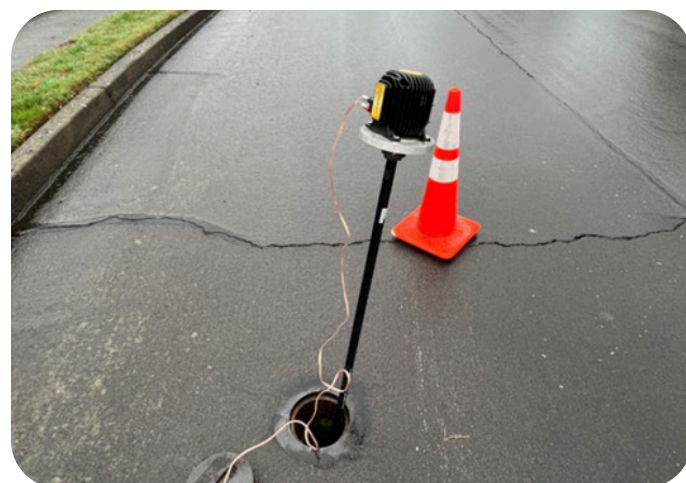
KenWave's DRI system in action: a wave generator introduces vibroacoustic signals into the pipeline to assess structural integrity—all without excavation. Photo taken during the Gresham, OR pilot project.

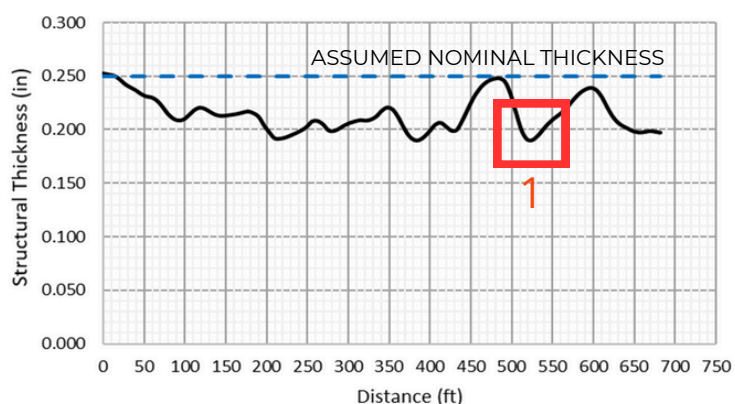
Graph showing structural thickness measurements along the length of metallic pipe.

KenWave's application of DRI technology successfully achieved a structural thickness profile with a high resolution of 6 feet, pinpointing significant degradation across inspected lengths. To verify the DRI results, the City of Gresham conducted a validation project using ultrasonic testing (UT) on pipe coupons from seven specific locations. The UT testing corroborated the DRI findings with an impressive 95% to 99% accuracy rate, confirming the reliability of KenWave's technology in assessing both CI and DI pipes.
