# Validated Condition Assessment of Metallic Water Mains in the City of Gresham

CITY OF  
GRESHAM  
OREGON

## Innovating Water Main Assessment with Confidence and Clarity

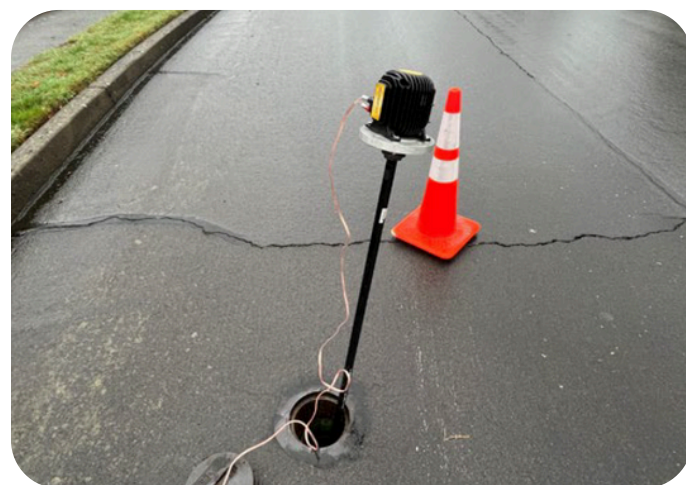
*KenWave's DRI system in action: a vibration generator introduces vibroacoustic signals into the pipeline to assess structural integrity—all without excavation. Photo taken during the Gresham, OR pilot project.*

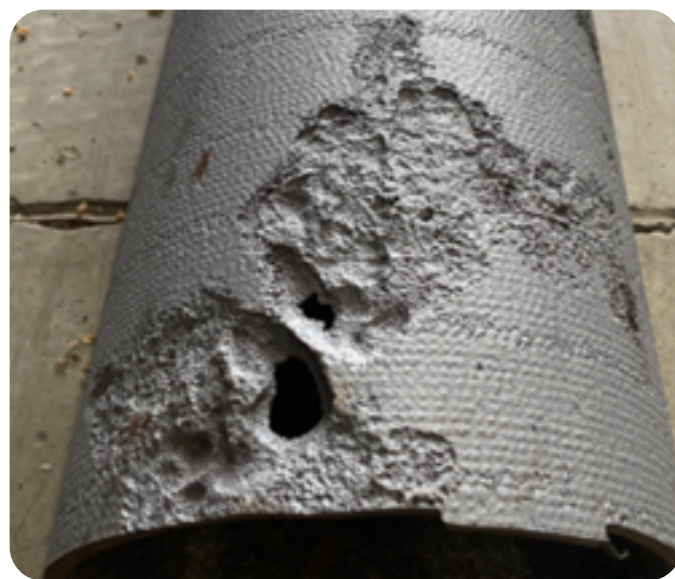
*Validation of KenWave's DRI solution showing at location 1 distress on a section of ductile iron pipe.*

KenWave's application of DRI solution successfully achieved a structural thickness profile with a high resolution of 6 feet, pinpointing significant degradation across inspected lengths. To verify the DRI results, the City of Gresham conducted a validation project using ultrasonic testing (UT) on pipe coupons from seven specific locations. The UT testing corroborated the DRI findings with an impressive 95% to 99% accuracy rate, confirming the reliability of KenWave's technology in assessing both CI and DI pipes.
