# Non-Invasive Condition Assessment of Asbestos Cement Mains

**brabant Water**

## Brabant Water's Inspection Challenge

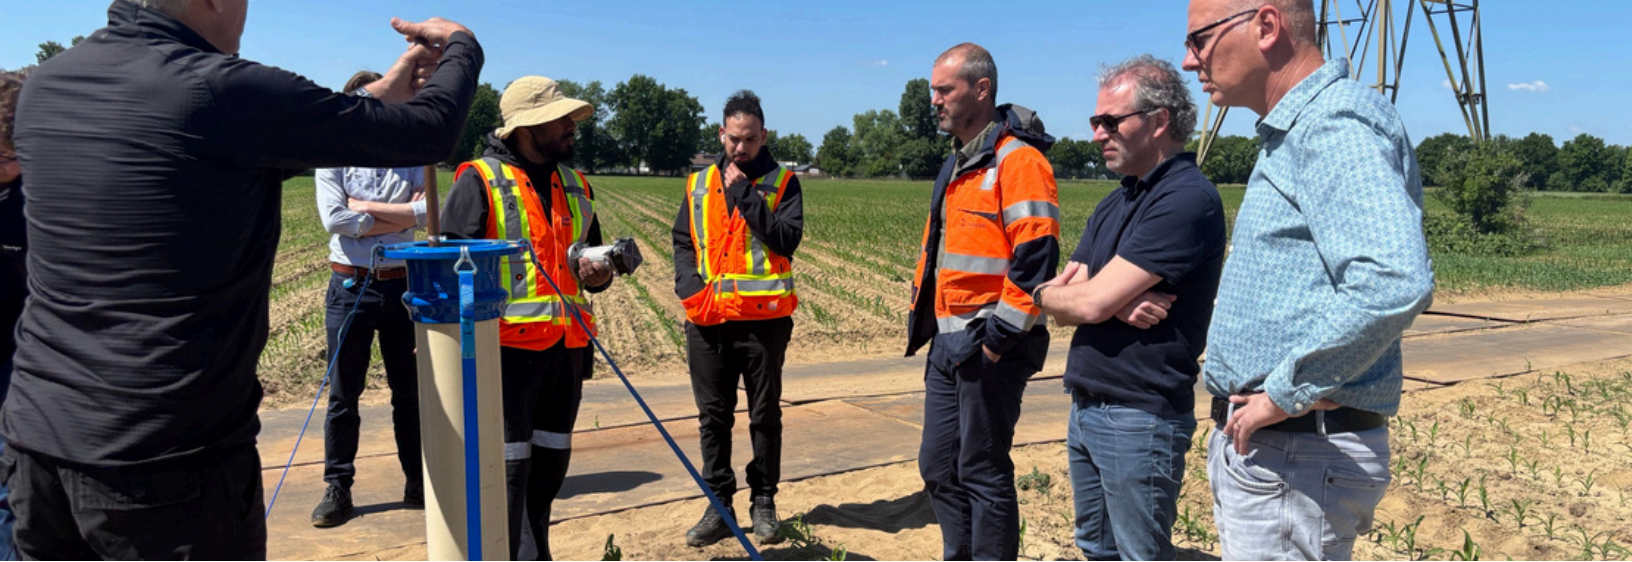
Brabant Water deployed a novel temporary potholing technique to overcome high groundwater conditions and complete the inspection with minimal impact to farmland.
